Report on the Grey Water System on Chumbe Island, May 2009

CHUMBE ISLAND
CORAL PARK
Zanzibar Tanzania

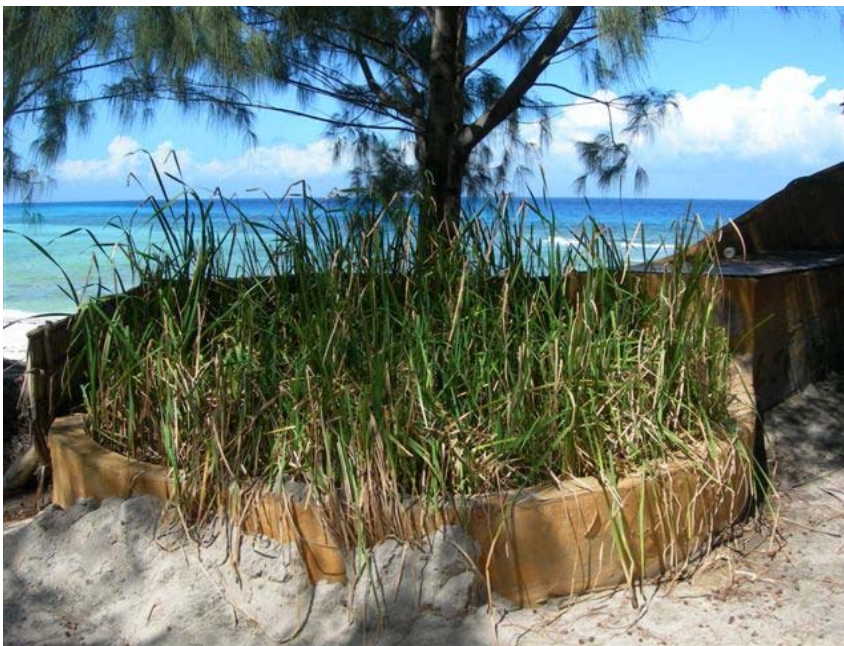
Picture 1. The new well-functioning grey water filtration system

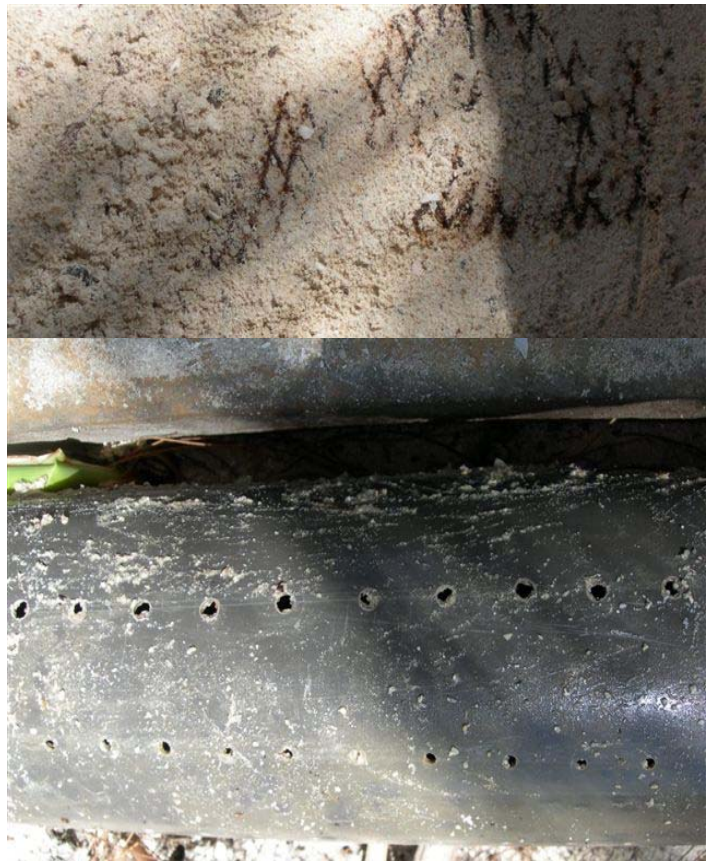
Figure 2. The rusty mesh (above) and the pipe with non-clogged holes (below)

Between the 6th and the 18th of May 2009 the two basins were emptied, all the parts were checked for possible problems, leakages and other failures. The result was overwhelmingly positive - everything was in perfect shape! The sand was still porous all the way to the bottom, the pipes were well functioning and not clogged, the iron mesh was rusty and functioning, the main basins had no leak and there was no bad smell, even at the very bottom of the sand.

After the system had been checked and dried, the grease trap was lined with new cement to prevent leakages, and the refilling process was started. On the bottom of the basins the pipe was placed according to Dr. Eberhard Böhm's original description; slightly tilted, with the holes placed downwards, surrounded by gravel and covered with a rubber mat (to avoid the sand to mix with the gravel and clog the holes). On top of the pipe, layers of new sand were put, including the rusty iron mesh. The very top layer was planted with fresh reed and the grey water system was ready for a new season to be started again.
